RC10GT PERFORMANCE UPDATE:

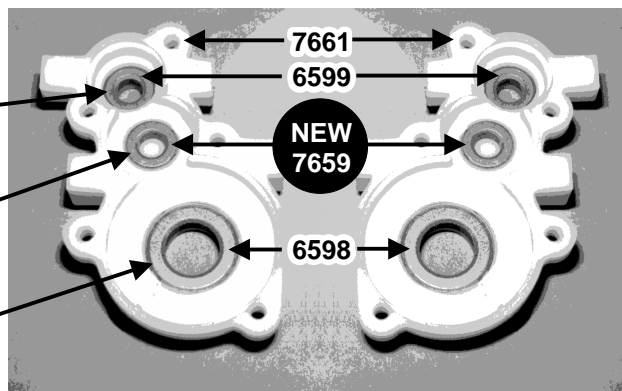
We improved the performance of the Sport Gas Truck by making a parts change inside the transmission. The picture to the right replaces Fig. 67 of your manual. It shows that we have replaced the two center #6599 bushings with the new #7659 idler gear shaft ball bearings.

BRONZE #6599
3/16 x 3/8
unflanged bushing

SILVER #7659
3/16 x 3/8
unflanged bearing

BRONZE #6598
3/8 x 5/8
unflanged bushing
